Inspection Report

Property Address:
542 Downtown Street
Charleston, SC 29403

A to Z Home Inspections

Date: 5/1/2006	Time: 8:45 PM	Report ID: 542 Downtown Street
Property: 542 Downtown Street Charleston, SC 29403	Customer: Sample Client	Real Estate Professional: Real Estate Agent Your

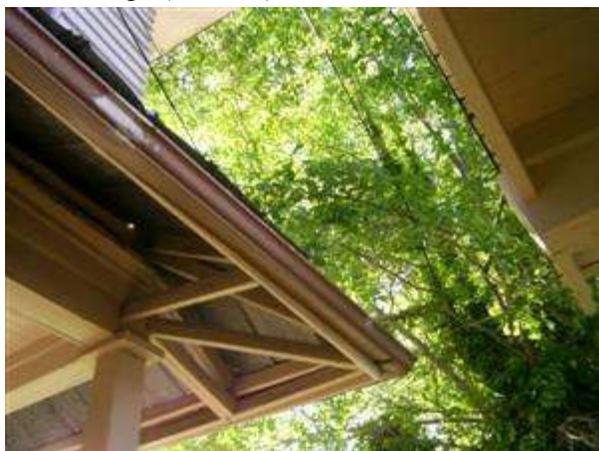
1.0 Picture 1

Roof covering is metal or tin and a metallic coating has been applied. The roof may need periodic maintenance of these coatings. (Picture 1) Tree limbs that are in contact with roof or hanging near roof should be trimmed.

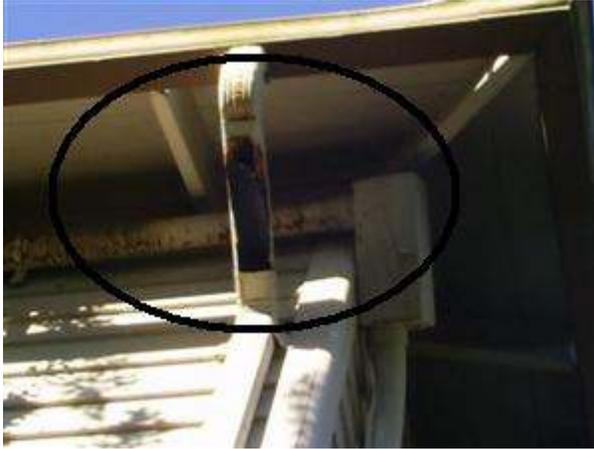
1.4 Picture 1

(Picture 1) Gutter is rusted and deteriorated in various areas throughout. Needs replacing. (Picture 2) Downspouts need elbows and splash-blocks at front, rear and sides of home. (Picture 3) Gutter needs to be tightened against home sealed at left side (facing front).

(Picture 1) Gutter is rusted and deteriorated in various areas throughout. Needs replacing.(Picture 2) Downspouts need elbows and splash-blocks at front, rear and sides of home.(Picture 3) Gutter needs to be tightened against home sealed at left side (facing front).

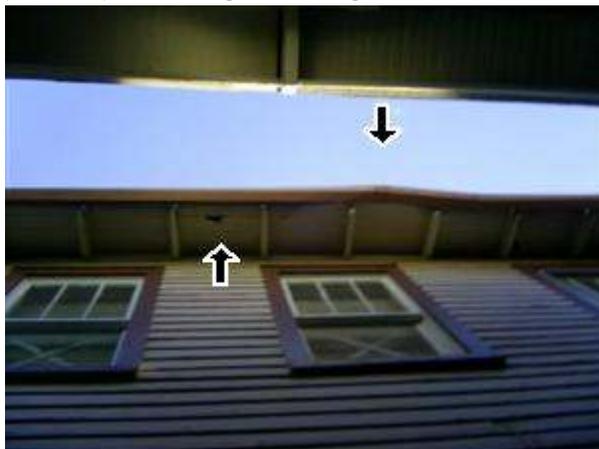
2.0 Picture 1

(Picture 1) Eave and gutter damage on side of the home. Recommend repair of the damaged areas.

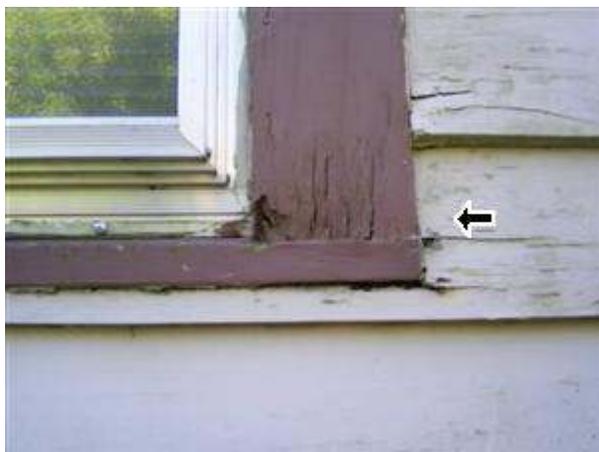
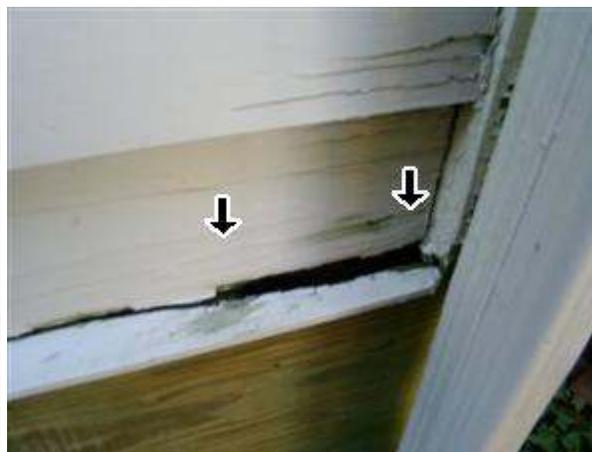
Water damaged siding in several areas of the home. Budget for repairs of these areas in the near future to preclude further deterioration.

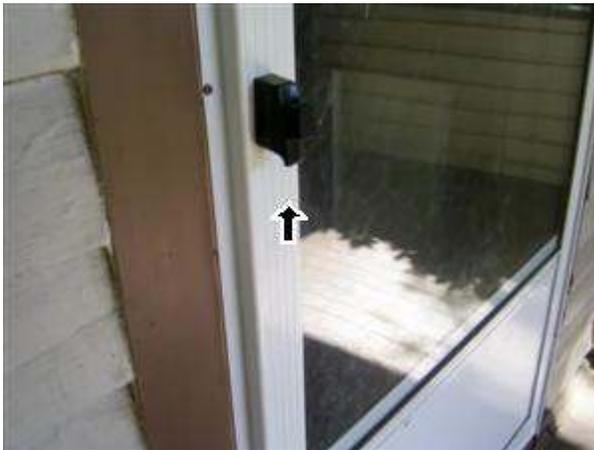
2.3 Picture 1

Broken handle on the downstairs unit storm door.

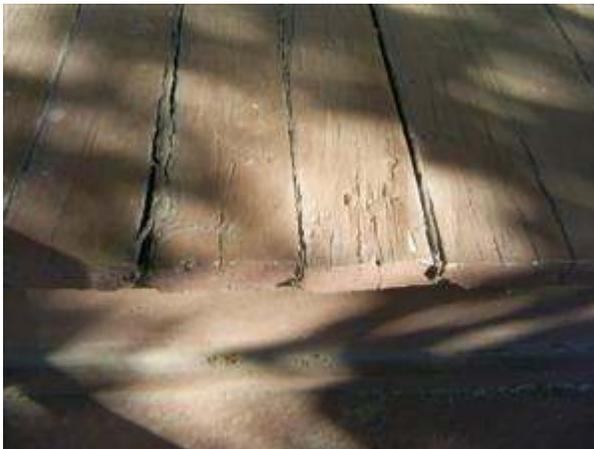
2.4 Picture 1

Wood floor decking on covered porch at front of home deteriorated. Further deterioration can occur if not repaired. Recommend repair or replace by a qualified contractor.

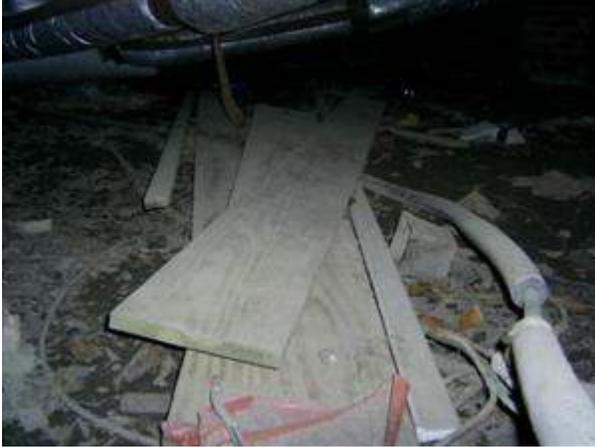
2.6 Picture 1

Lots of debris under the home. Recommend removal to help in the control of wood destroying insects.

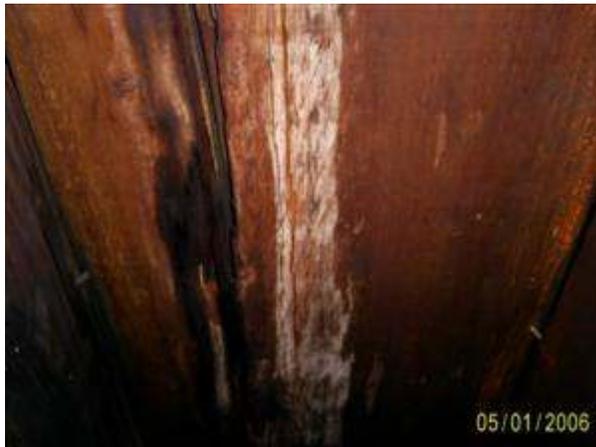
4.1 Picture 1

2x8 rafters deteriorated along valley (above Guest bedroom). Area still remains strong. Not cost effective to replace until next roof. Recommend a qualified contractor repair as needed at that time.

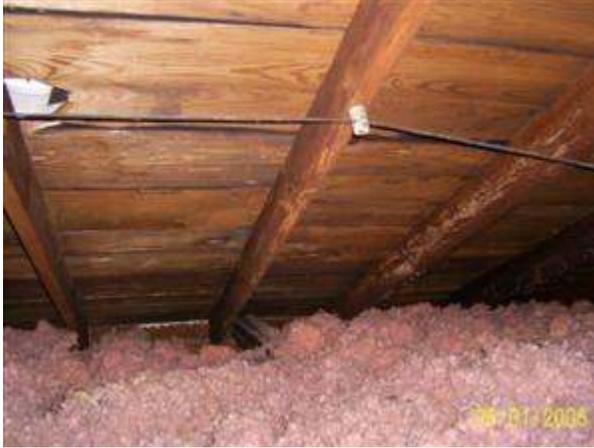
4.7 Picture 1

(Picture 1) Old knob and tube wiring still in place in the attic. Recommend removal of outdated and unused wiring.

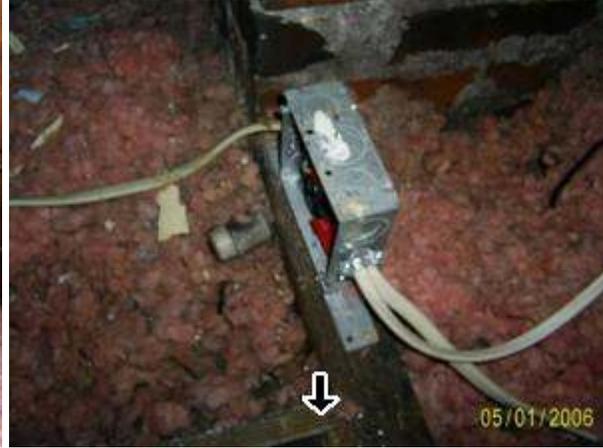
4.7 Picture 2

(Picture 2) Open junction box located too close to the scuttle hole (arrow points to opening of access) Recommend closing the box and repositioning to prevent physical damage. Recommend a licensed electrician perform all work that involves wiring.

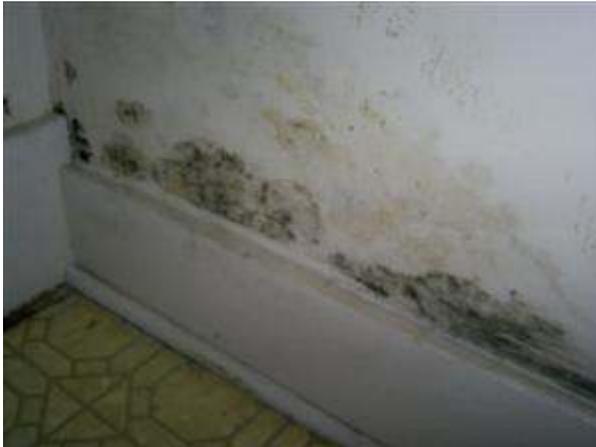
5.1 Picture 1

Signs of microbial growth present on walls along downstairs water heater room area in several areas. I did not inspect, test or determine if this mold is or is not a health hazard. The underlying cause is moisture. I recommend you contact a mold inspector or expert for investigation or correction if needed.

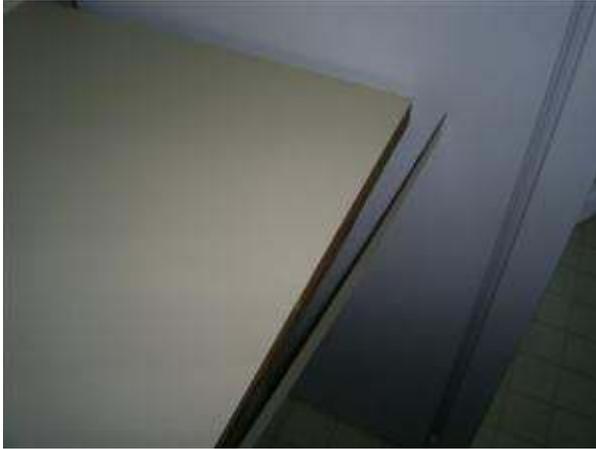
5.3 Picture 1

Laminated countertop is loose, not fastened securely at counter left of the refrigerator in down unit. This is a cosmetic issue for your information. Recommend repair or replace as necessary.

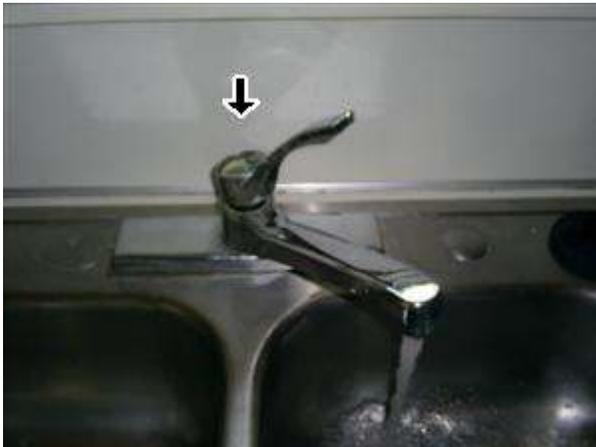
5.6 Picture 1

(Picture 1) Broken faucet top upstairs unit. (Picture 2) No rubber throat in the sink to disposal upstairs. Disposal (Kenmore) did not operate.

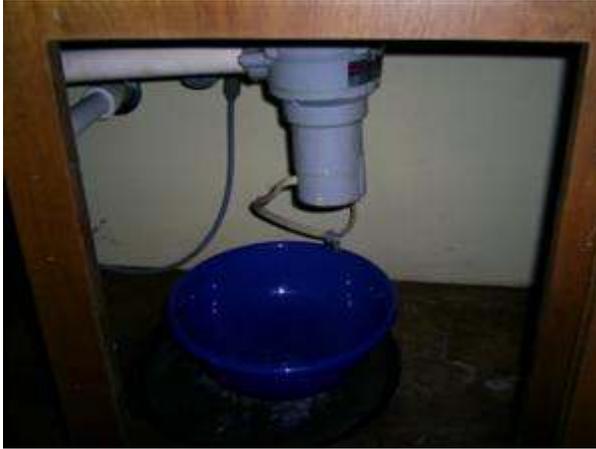
5.8 Picture 1

Disposer in the downstairs unit leaking. Recommend repair by a licensed plumber.

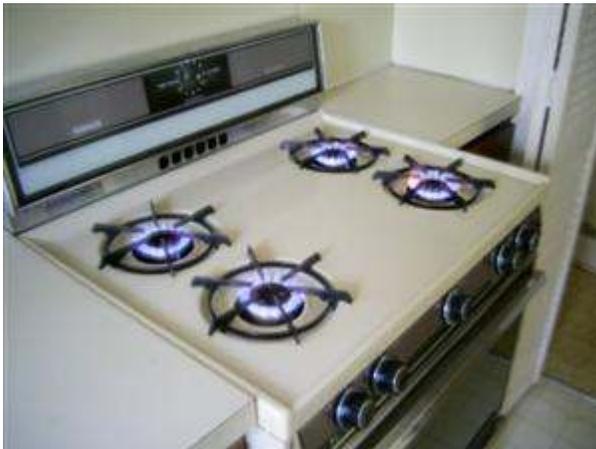
5.10 Picture 1

Both units had cook top burners that lit. Neither oven would heat up. Recommend repair by a qualified person.

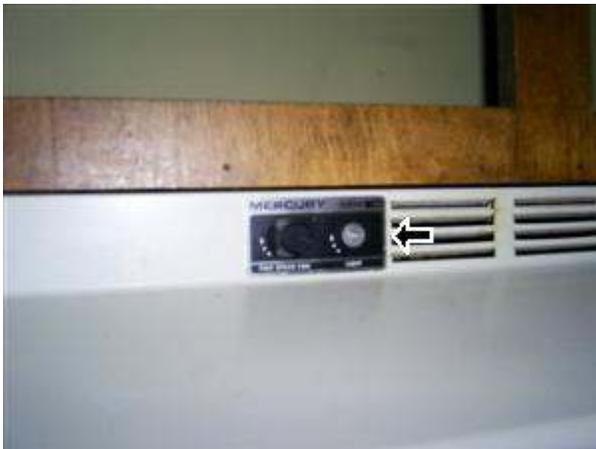
5.11 Picture 1

Missing the light knob. Still operates okay.

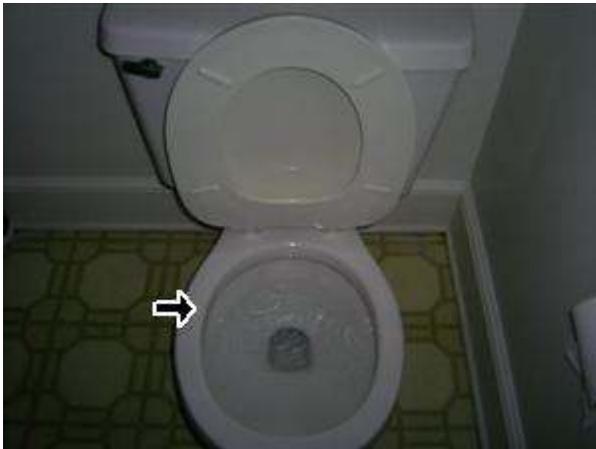
6.4 Picture 1

This toilet in the upstairs unit ran after being flushed. I turned it off with the twist valve. Recommend repair by a qualified person.

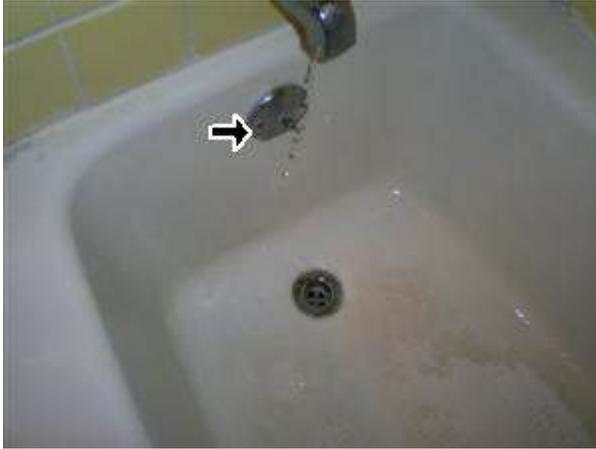
6.5 Picture 1

Stopper of the downstairs tub inoperative.

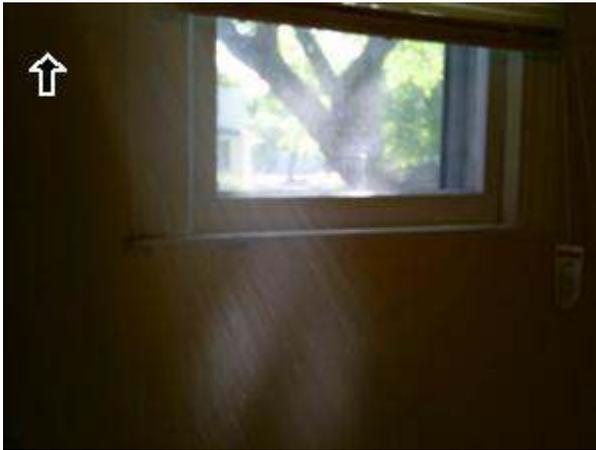
6.9 Picture 1

Shower head in the downstairs bath above the window. Water damage has occurred to this sill. Recommend raising the window above the shower line.

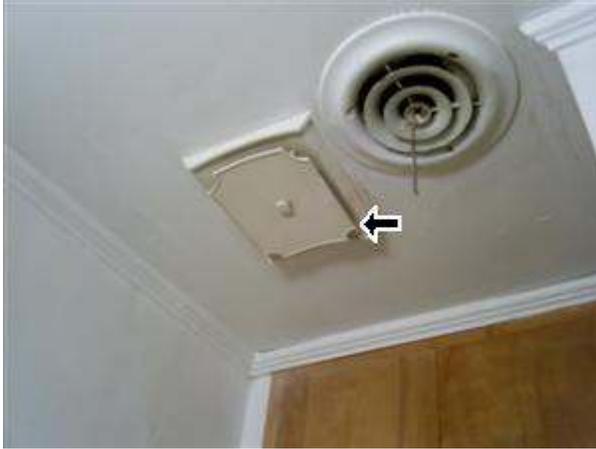
6.10 Picture 1

This vent was very weak in the upstairs unit. Recommend repair by a qualified person.

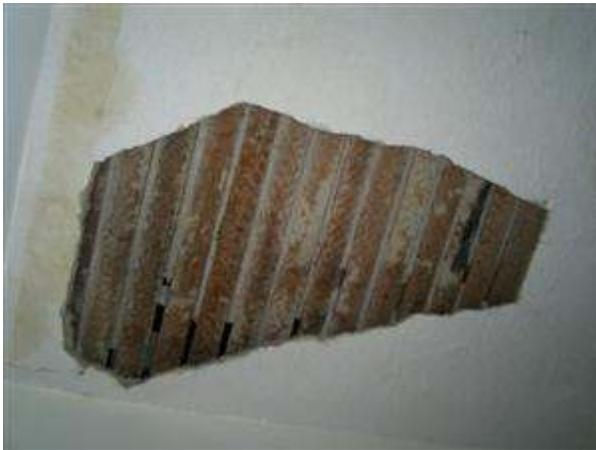
7.0 Picture 1

Plaster on ceiling is missing in areas at downstairs at hallway closet room. While this damage is cosmetic, it needs to be repaired. Recommend repair or replace as needed using a qualified person.

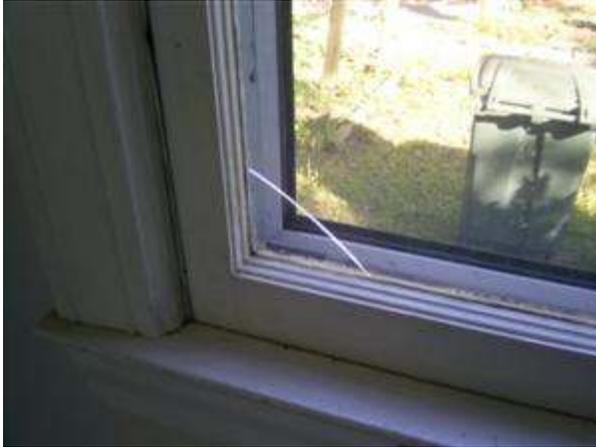
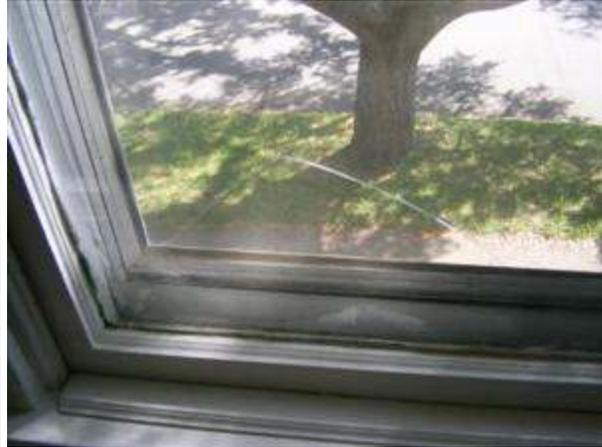
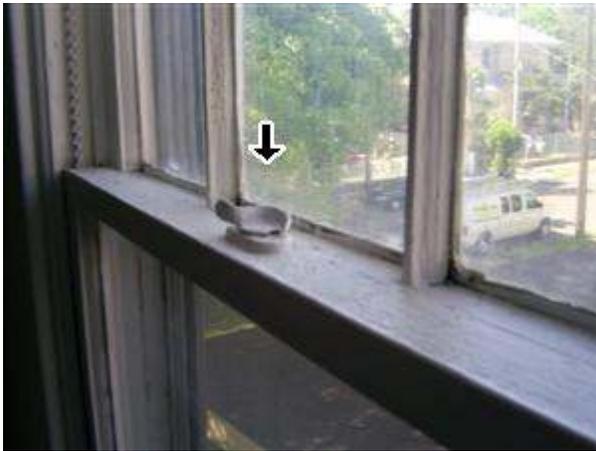
There are cracked glass in some windows throughout home.(Picture 3) Some windows upstairs missing the lock latch.

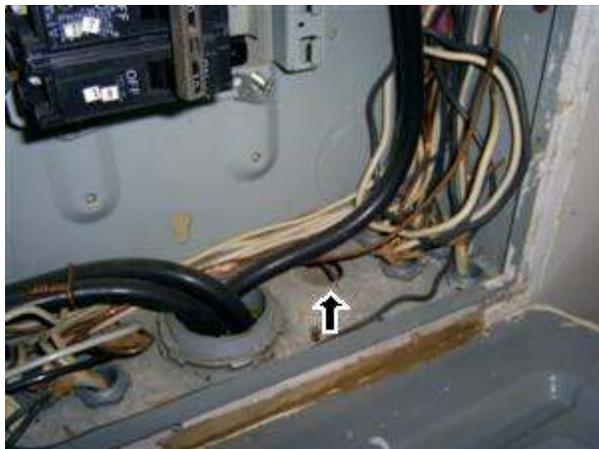
8.1 Picture 1

Problem(s) discovered in panel such as (Picture 1) amateur wiring installation, (Picture 2) ganged neutrals and (Picture 3) neutrals being used as a 'hot' (not labeled) and any other problems that an electrician may discover while performing repairs need correcting. Recommend a licensed electrician inspect further and correct as needed.

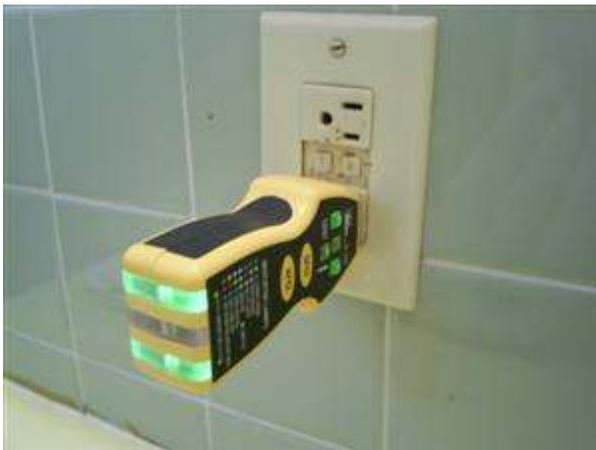
8.5 Picture 1

(Picture 1) This GFCI in the upstairs bath did not trip.(Picture 2) This GFCI in the upstairs powder did not trip (likely tied to the bathroom that was inop)

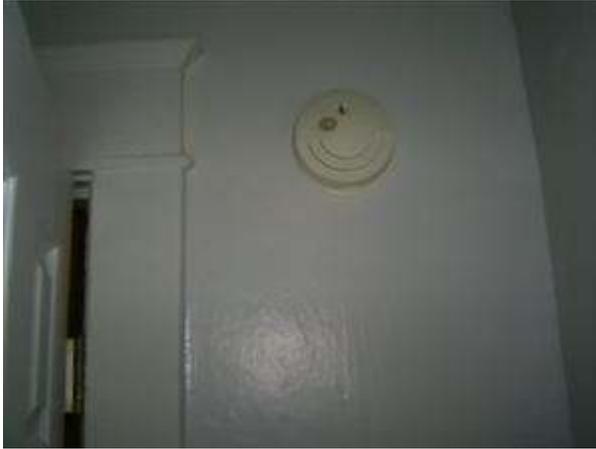
8.8 Picture 1

Would not test in the downstairs unit. Only 3 of the upstairs tested okay (battery beeping on one of them). Recommend repair or replacement of all the smoke detectors.

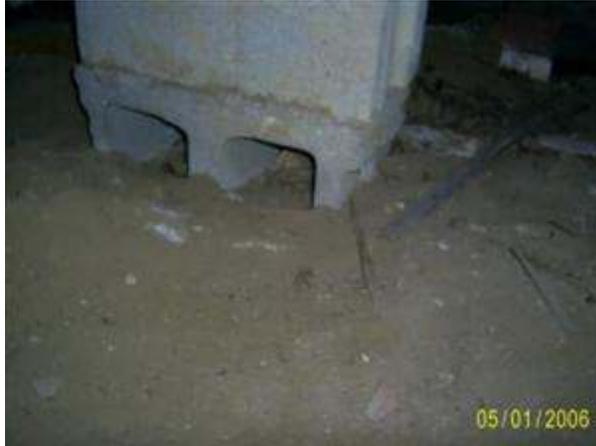
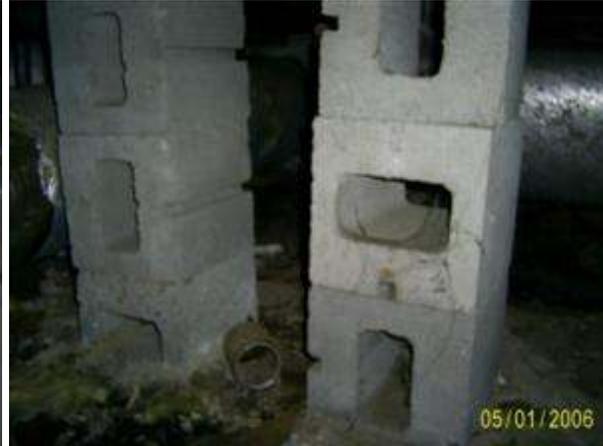
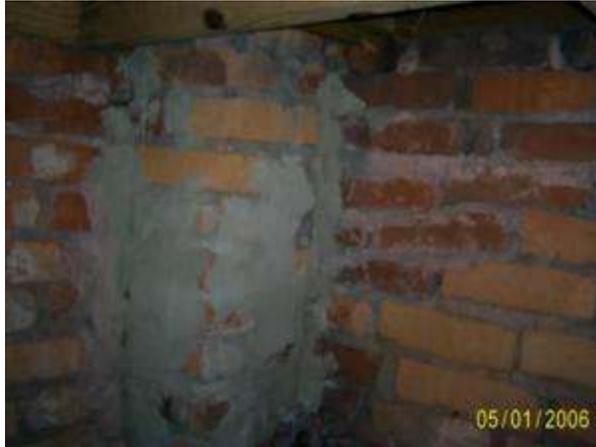
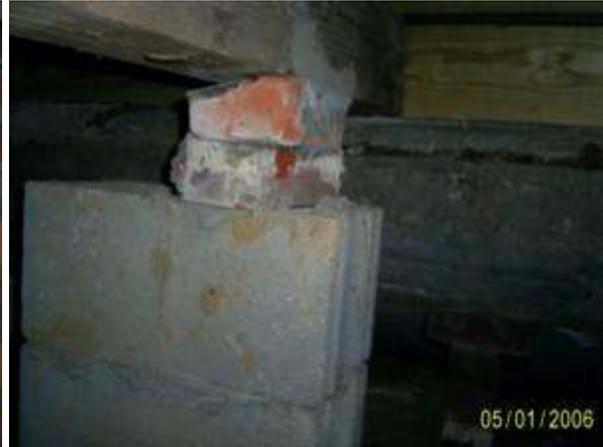
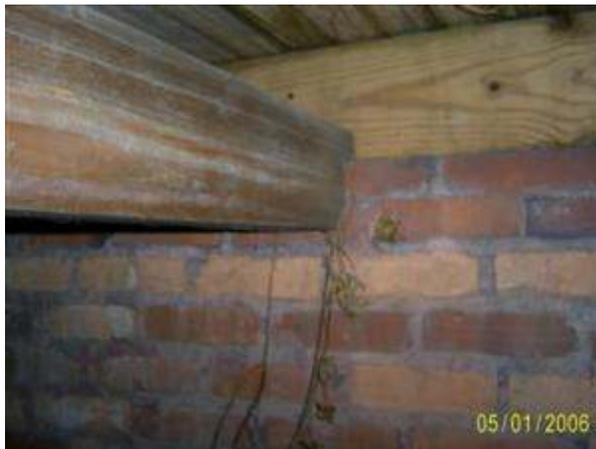
(Picture 1) (Picture 2) Several of the concrete block reinforcement piers were installed incorrectly. Original piers are still in place and still appear to be supportive as well. (Picture 3) Repaired area front left corner of the home. (Picture 4) Questionable support at the pier toward the middle of the porch area. (Picture 5) Good rim joist repair and ledger at the front of the home.

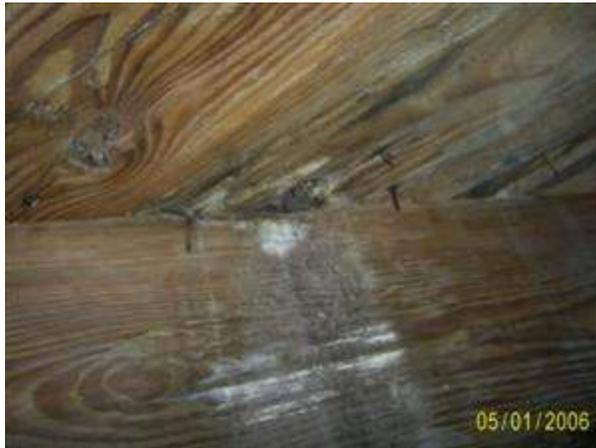
9.3 Picture 1

A couple areas of subfloor and the nearest joist shows signs of either water damage or damage by some other organism. This area is still hard or no longer actively leaking. Some of these areas may be candidates for replacement during renovations.

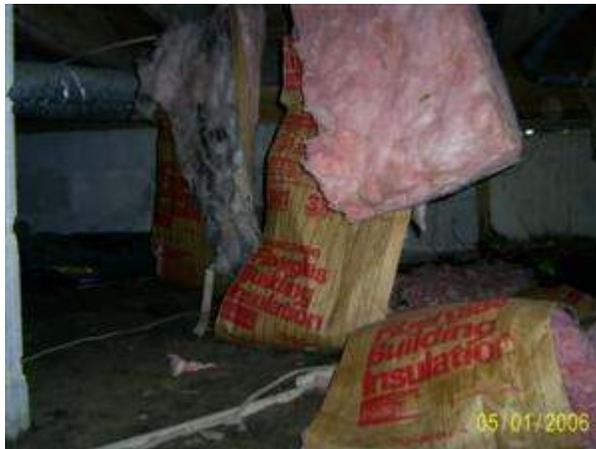
9.5 Picture 1

(Picture 1) Wet insulation hanging down toward the rear of the home. (Picture 2) Shows insulation incorrectly installed in several areas under the home. Kraft facing should be installed 'toward the heated area' not toward the ground. Vapor barrier (plastic) on crawlspace ground is missing. A vapor barrier provides added protection to floor system from moisture or dampness that can enter from ground. Recommend repair or replace as needed using a qualified person.

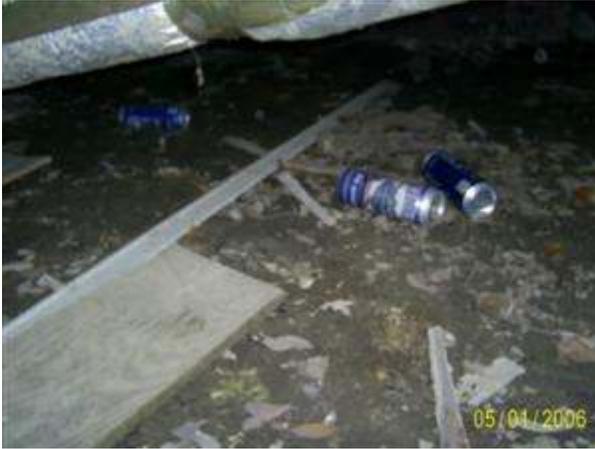
9.7 Picture 1

Some 'recyclables' left by the HVAC technicians near the crawl space air handler.

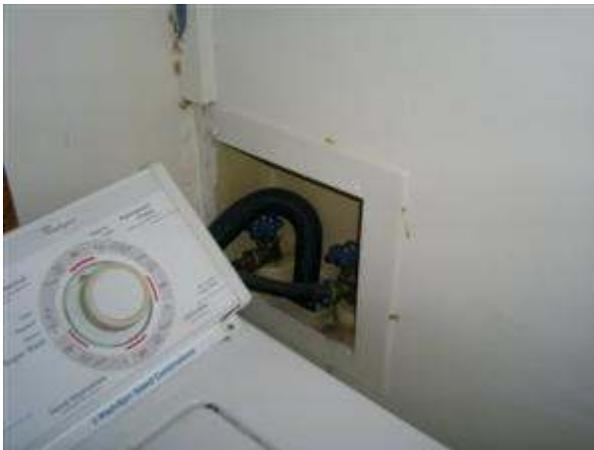
10.0 Picture 1

(Picture 1) Recommend replacement of the rubber washer hoses with braided steel hoses which are less likely to rupture and cause severe water damage to the home.

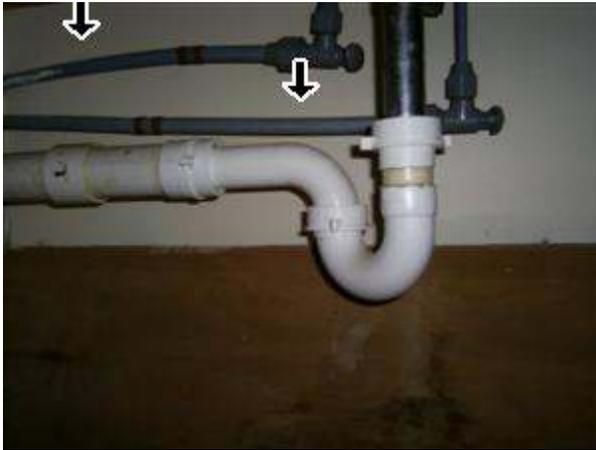
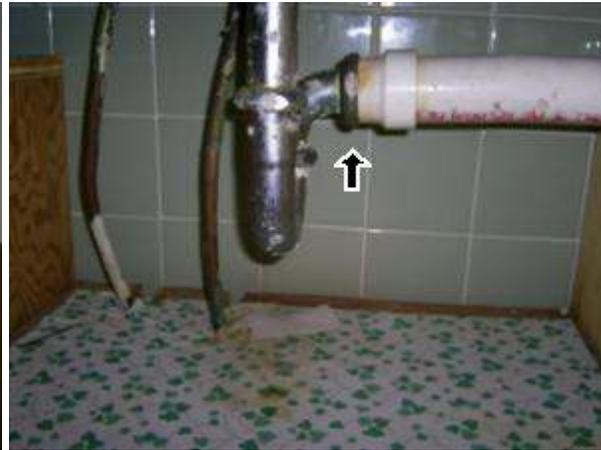
Polybutylene plastic plumbing supply lines (PB) are installed in the subject house. Polybutylene has been used in this area for many years, but has had a higher than normal failure rate, and is no longer being widely used. Copper and Brass fittings used in later years have apparently reduced the failure rate. This subject house has copper fittings and brass fittings. For further details contact the Consumer Plumbing Recovery center at 1-800-392-7591 or the web at <http://www.pbpipe.com> (Picture 2) Galvanized to PVC union not leaking at this time. Monitor this area for leaks.

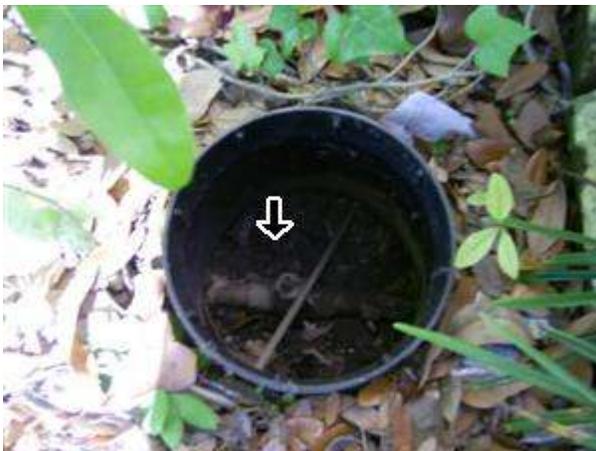
10.4 Picture 1

In front of the home. No knob (or lever) to actuate.

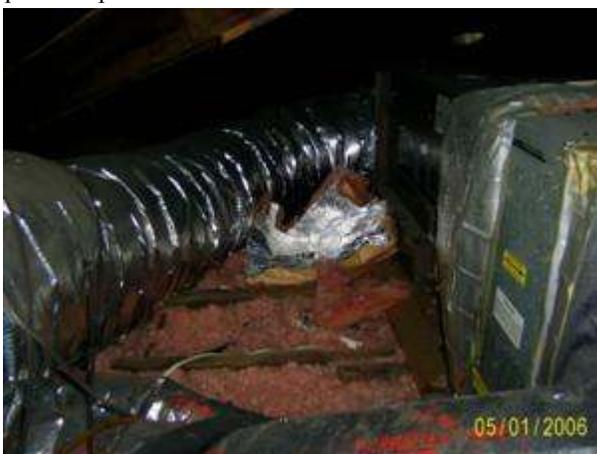
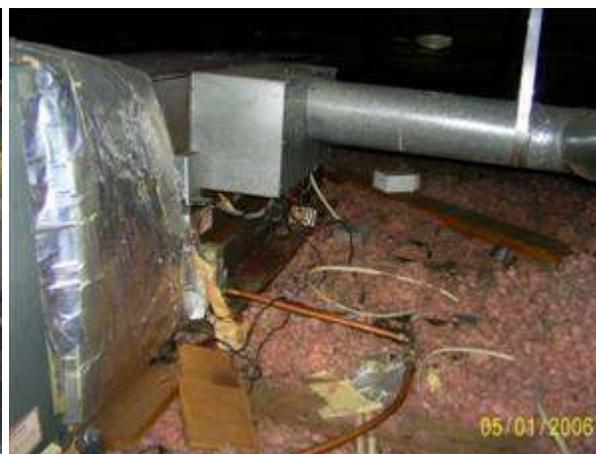
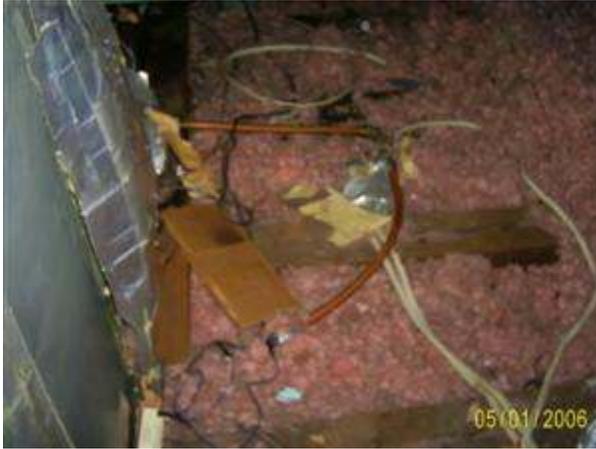
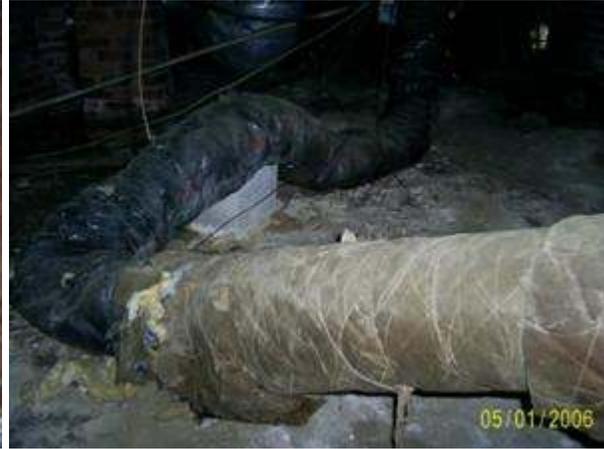
Debris all over the air handler unit in the attic. Recommend installer (if it can be determined who it was) clean the area up (regardless of any warranty) (Picture 4) This ductwork is laying on the ground. Recommend repair and support by a qualified person.

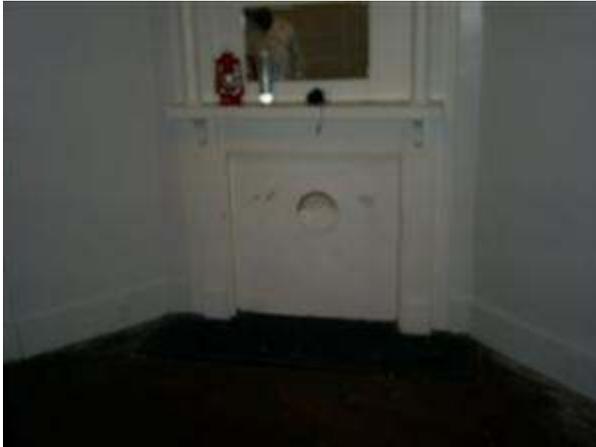
11.6 Picture 1

Currently closed off in the downstairs unit.
