Inspection Report

Property Address:
542 Downtown Street
Charleston, SC 29403

A to Z Home Inspections

Date: 5/1/2006	Time: 8:45 PM	Report ID: 542 Downtown Street
Property: 542 Downtown Street Charleston, SC 29403	Customer: Sample Client	Real Estate Professional: Real Estate Agent Your

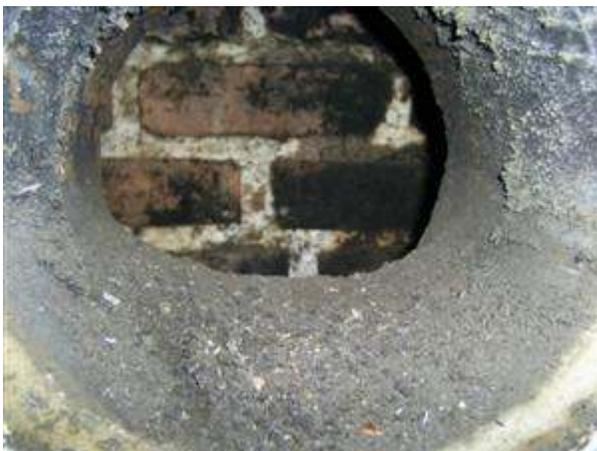
11.3 Picture 1

There are a wide variety of chimneys, which represent an even wider variety of interrelated components that comprise them. However, there are three basic types: single-walled metal, masonry, and pre-fabricated metal ones that are commonly referred to as factor-built ones. Single-walled metal ones should not be confused with factory-built metal ones, and are rarely found in residential use, but masonry and factory-built ones are a commonplace. My inspection of them is that of a generalist, not a specialist, and meets industry standards. However, significant areas of chimney flues cannot be adequately viewed during a field inspection, as has been documented by the Chimney Safety Institute of America, which reported in 1992: 'The inner reaches of a flue are relatively inaccessible, and it should not be expected that the distant oblique view from the top or bottom is adequate to fully document damage even with a strong light.' Therefore, because my inspection of chimneys is limited to those areas that can be viewed without dismantling any portion of them, and does not include the use of specialized equipment, I can not guarantee their integrity and recommend that they be video-scanned before the close of escrow.
